FACTSHEET RISK REDUCTION MEASURES

Flood protection measures in Libín - furrow

Libín (South Bohemia Region, Czech Republic)

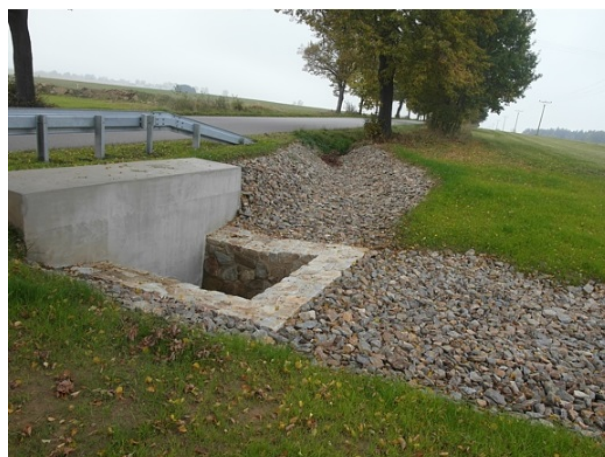
Culvert under the road

The flood protection measures of the village Libín consists of a bypass channel built as a furrow with a slight side slope. The furrow is dimensioned for a 100-year event. The length of the furrow is 625 m and it is followed by a watercourse in fiberglass pipes. The diameter of the pipes is 900 mm, the length is 155 m and the capacity corresponds to a 50-year event. The pipe outlet flows into a nameless watercourse which flows into the Spolský stream. As part of the realized construction the pressure under road had to be considered, a water pipe was relocated and other technical infrastructures were built. The construction cost amounted to CZK 6 million. (Source: Povodí Vltavy, state enterprise)

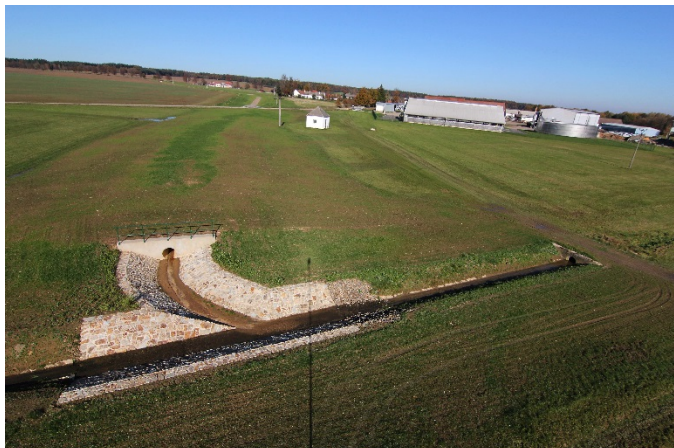
State after implementation

Despite the difficulties and long time from the amendment of the spatial plan to its realization, the bypass channel is fulfilling its function.

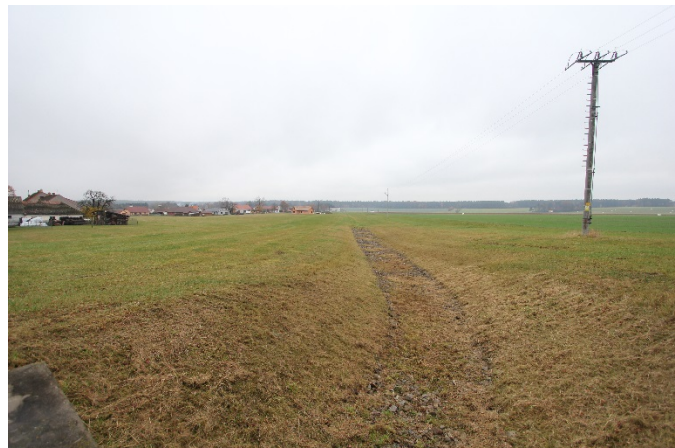
Furrow
