FACTSHEET RISK REDUCTION MEASURES	
Flood protection measures Přední Ptákovice	
Where was it implemented?

Strakonice, district Přední Ptákovice (South Bohemia Region, Czech Republic)	
Fields of action	
<ul style="list-style-type: none"> • Farmland, forest, settlement area 	
Related to measure from the catalogue of measures	
<ul style="list-style-type: none"> • Smal dikes and pits • Furrows • Linear protection measures • Event and damage documentation, event analysis 	<p>Source: VRV- Company Vodohospodářský rozvoj a výstavba a.s., Prague</p>
Area characterisation	
<ul style="list-style-type: none"> • Area type: non-Developed area • Landscape type: arable land/field 	
Problem	
Heavy rains wash off the arable land and flood the residential area as well as the areas with development potential. The flooded area is 10 ha. During a local heavy rain event in 2014, a 30 cm high layer of mud remained on the streets.

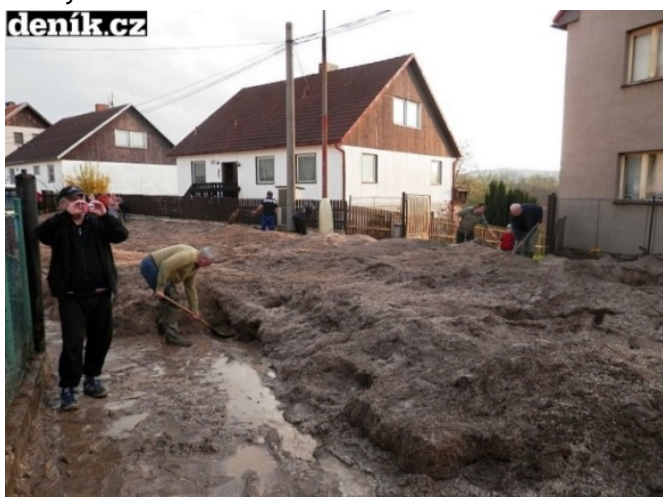
Heavy rain event in 2014

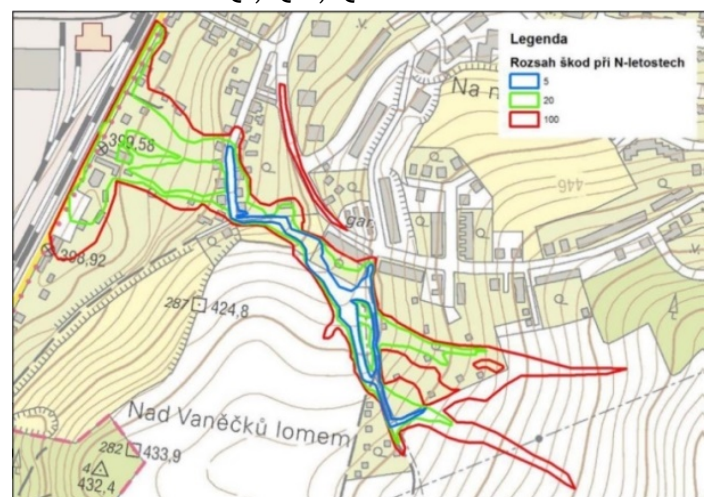
Vulnerable areas Q5, Q20, Q100

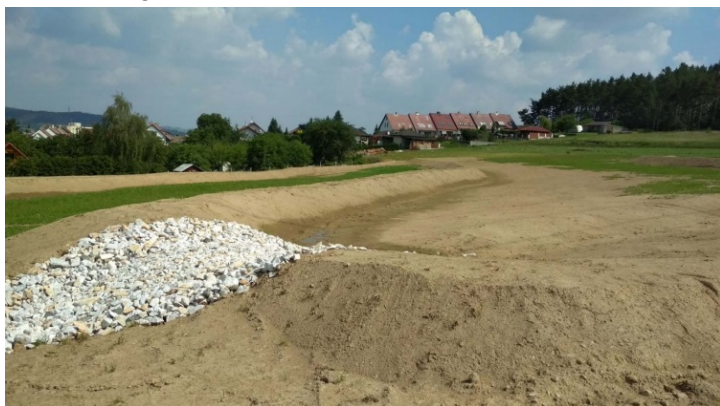
State during realization

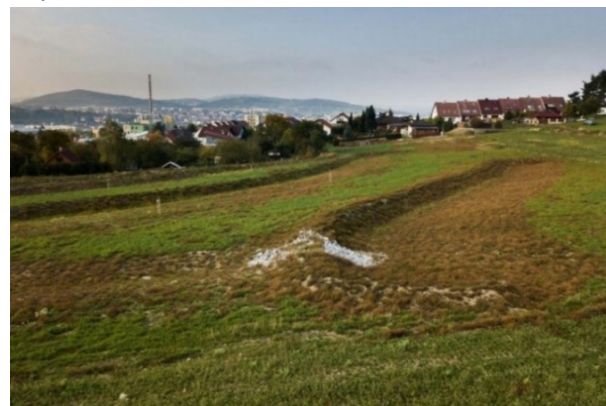
Implemented measures

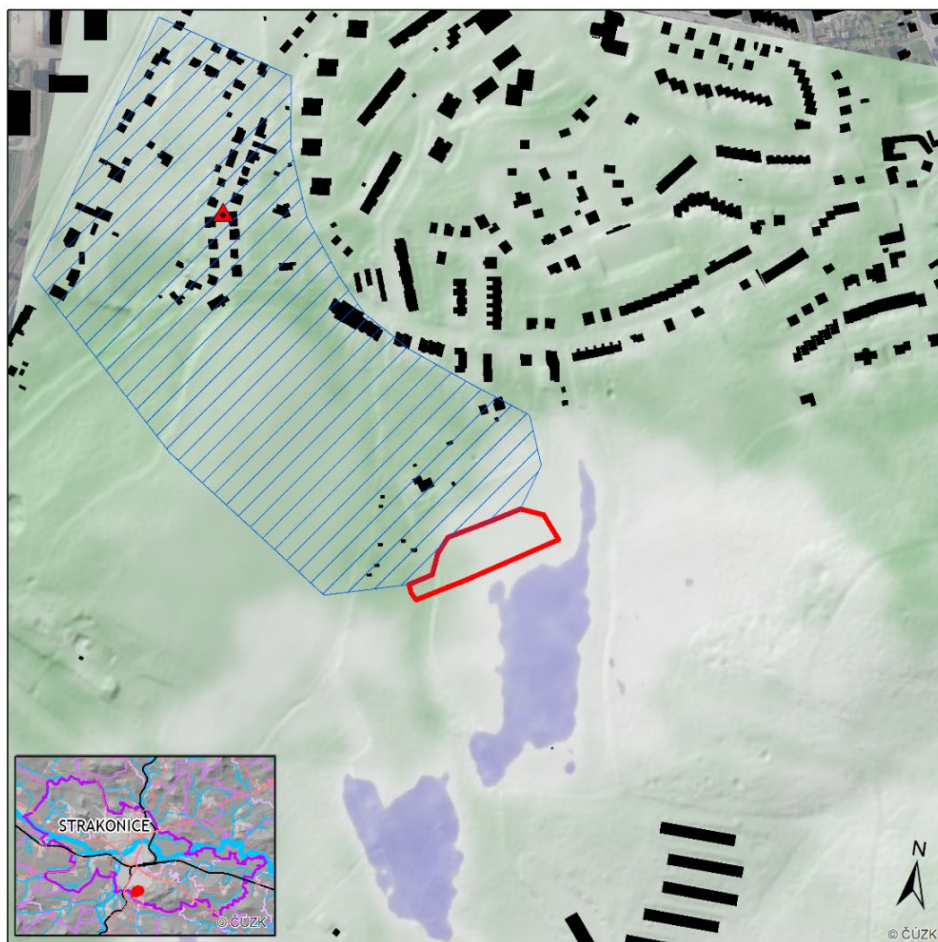
SITUATION AFTER HEAVY RAIN

- ▲ Heavy rain event in 2014 (photo)
- Risk reduction measure
- Vulnerable area
- Building (source RUIAN)

satellite image Sentinel 15.07.2019 - NDWI

summary of precipitation from 14.07.2019
