## FACTSHEET RISK REDUCTION MEASURES

### Stopping inflow structure from being clogged - Kirchsteigbachtal

City of Meissen, Saxony, Germany

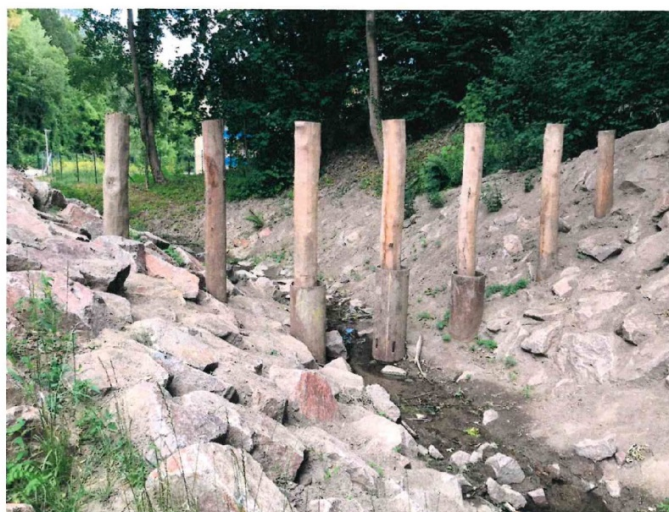
Vertical wooden racks acting as a debris barrier  
Source: M. Sura, Hoch- und Tiefbau GmbH

In the course of the stream, → **constructions for sediment and debris retention** (e.g. vertical wooden racks) have been installed in the streambed. They act as a barrier against heavy debris like branches.

At the lower part of the brook "Kirchsteigbach", a gravel trap basin with overflow has been constructed. Its best performance was determined by terrain modelling. The bedload barrier installed in the stream course is intended to prevent the inflow structure from being clogged with debris (picture above).

The wooden racks act as a barrier to stop carried trees and branches. Otherwise their size, shape and floating energy could not only clog, but also damage and destroy the inflow structure at the lower parts of the brook. The gravel trap basin acts as a detention basin, catches smaller debris and reduces the peak discharge. Both measures also stop floating refuse.
