FACTSHEET RISK REDUCTION MEASURES

Bank reinforcement for the course of the brook - Kirchsteigbachtal

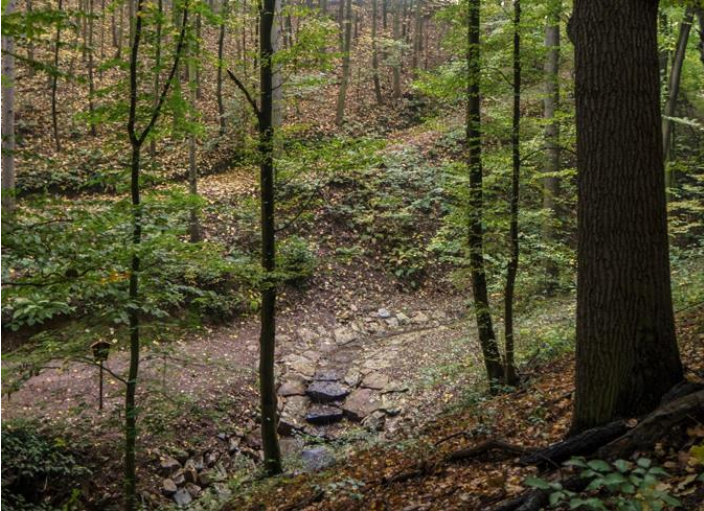
Description and aim	
<p>The instream measure is a near-natural bank reinforcement to maintain the course of the stream in the Stadtwald area. Embankments in the bump curves (undercut banks) of the brook course should prevent the river from overflowing its banks.</p> <p>Terrain modelling was carried out in the lower area to create additional retention space and at the same time protect the banks from erosion.</p>	
Effect of measure	
<p>The embankment prevents the riverbank from flooding and uncontrolled water runoff, coming along with mud and sediment deposit. It prevents erosion and maintains the natural river course and its streamflow.</p>	
Description of implementation	
Effect horizon: long-term	Costs: very low, funded by flood damage repair package 2013
Initiator / responsible: City of Meissen	Involved stakeholders: City of Meissen, building department
