FACTSHEET RISK REDUCTION MEASURES

Appropriate design of unsealed roads and stream crossing in forests - Korbitzer Schanzen, Kirchsteigbachtal

City of Meissen, Saxony, Germany

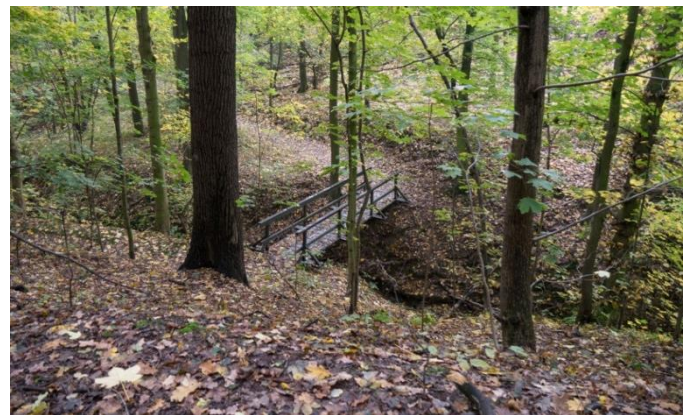
Appropriate construction design of a rebuilt bridge after the heavy rain event in the “Stadtwald” area.
Source: P. Voigt

Two bridges destroyed by the heavy rain event were rebuilt to reconnect the existing forest track network in the “Stadtwald” area (picture above). Destroyed culverts and bridges in nearby areas were replaced by fordings (picture next page). By this means the increased stream width as a result of the heavy rain event can be obtained to increase the runoff capacity while decreasing damage potential alongside the river. The natural characteristic of the stream with positive ecological effects is further ensured.

The use of glass fibre as construction material improves the resilience of the bridges and reduces upkeep in contrast to a wooden design. The stabilization of slope areas reduces erosion of debris and sediments. Recovery and reconnection of the forest track network by fordings (instead of bridges) prevent from log and debris jams and contribute hence to a controlled water runoff. Fordings simplify forest management, e.g. simple crossing of fordings for timber transports.

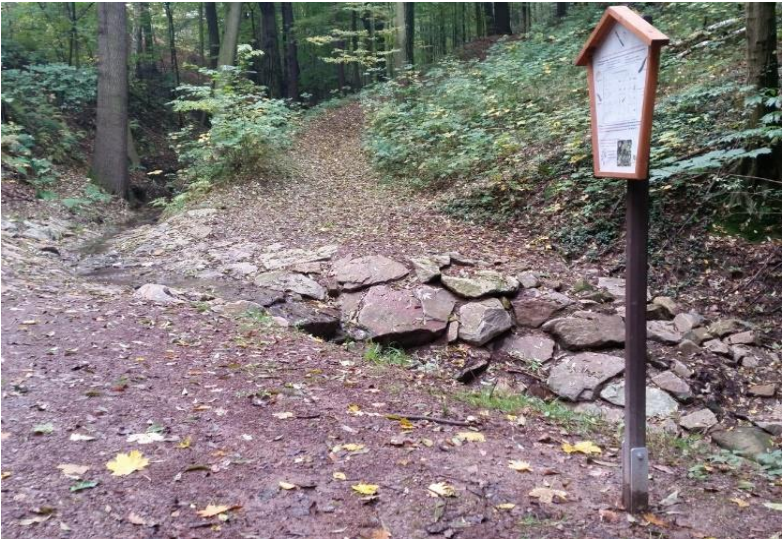
<p>Fording within the stream bed of the brook "Kirchsteigbach" Source: P. Voigt</p>	<p>Description of implementation</p>
	<p>Effect horizon: long-term</p>
	<p>Implementation: 11/2017 - 01/2018</p>
	<p>Costs: not known, funded by flood damage repair package 2013</p>
	<p>Involved stakeholders: building department, lower water authority, lower nature protection authority</p>
<p>Initiator / responsible: City of Meissen</p>	
<p>Lessons-learned</p>	
<p>Main success factor: The destruction of bridges due to the heavy rain event in 2014 led to a need for action, triggered a change into an alternative, constructive use of fordings and ensured funding of the measure.</p>	<p>Main challenge: The measure is located in a special area of conservation (SAC). Fortunately, obligations and restrictions were kept to a limited scale as the measures were regarded as reconstructions and not as new constructions.</p>

<p>Synergies / beneficial aspects: The whole area of "Stadtwald" is a local recreation area. The measure is regarded as a benefit for recreation by local residents and invites to take a walk in the forest. Fordings need a much lower upkeep than bridges and reduce the risk of log and debris jams.</p>	<p>Conflicts / constraints: Fordings limit the accessibility for wheelchair users and perambulators and might not be able to cross when the water level is high.</p>
<p>Key message to others starting with a similar task</p>	<p>Contact</p>
<p>Check for possible old, destructed or destroyed bridges. Ask inhabitants or consult maps for locations. Receiving a building permission for reconstruction might be easier than for a completely new construction.</p>	<p>City of Meissen, Municipal Building Office, Markt 1, 01662 Meissen E-Mail: stadtbauamt@stadt-meissen.de</p>
<p>Further information (in German)</p>	<p>Steffen Wackwitz (2015): Das Starkniederschlagsereignis in Meissen im Sommer 2014, in: WasserWirtschaft 9/2015, URL: https://www.springerprofessional.de/das-starkniederschlagsereignis-in-Meissen-im-sommer-2014/6110106, 13.11.2019. (in German)</p> <p>Stadt Meissen (2015): press realease - Naturnahe Instandsetzung des Kirchsteigbaches gelungen - Mehr Schutz vor Hochwasser und Starkregen, URL: https://www.stadt-meissen.de/8847.html, 13.11.2019.</p>
