FACTSHEET RISK REDUCTION MEASURES

Renewing of a pipe and inlet structure - Kirchsteigbachtal

City of Meissen, Saxony, Germany

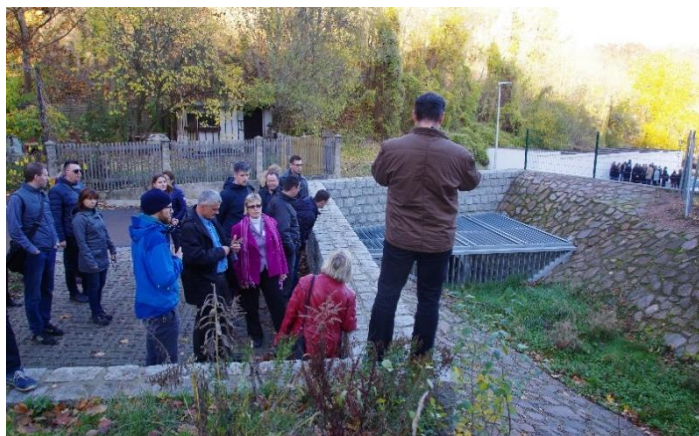
Renewed pipe and inlet rake at the lower part of the stream course
Source: Sabine Scharfe, LfULG

- destroyed stream pipe was enlarged (from 1.00 m to 1.40 m in diameter) and replaced by a new, reinforced concrete pipe according to DN 1400
- inlet was adapted to the enlarged pipeline and equipped with an → rake for for sediment and debris retention
- the destroyed street got asphalted, a pavement was built and installation surfaces for clearing out and upkeeping close to the inlet structure were established

The enlarged pipe enhances runoff. Discharge capacity was almost doubled. The inlet rake prevents from pipe blockage due to deposited debris. The enlarged pipe is no longer a narrow point for controlled water runoff in case of heavy rain events in the future.
