## FACTSHEET RISK REDUCTION MEASURES

### Repair of a mill ditch system and a quarry lake - Kirchsteigbachtal

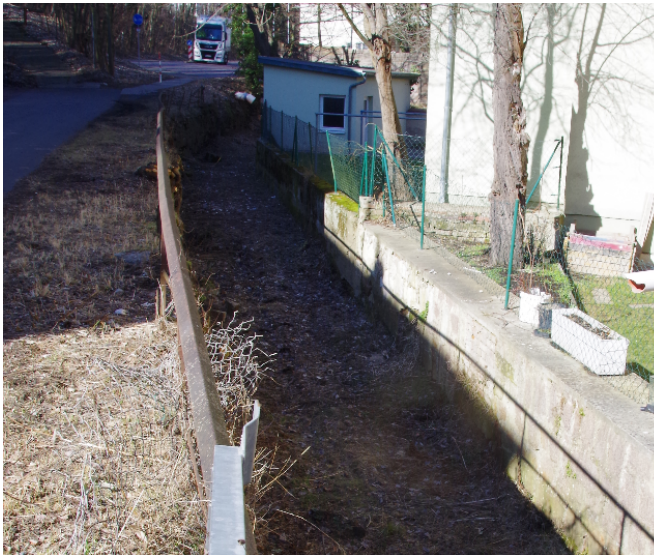
The old and unused mill ditch system “Mühlgraben” fortunately collected and redirected much water, mud and sludge during the heavy rain event and protected the residential area from damages. The functional benefits of the existing system of → **drainage ditches** for controlled surface runoff and for → **increasing the retention capacity of existing channels and floodplains** was recognised and the ditches were restored immediately after the heavy rain event (picture above). Restoring measures are not completed yet.

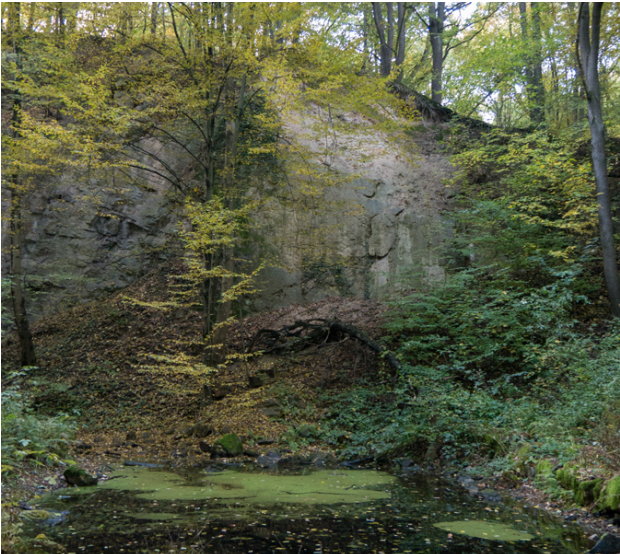
Additionally, the quarry lake “Kleiner Königssee”, located at the slope of a stone quarry (picture below), was connected to the “Mühlgraben” by intense erosion processes during the heavy rain event, which created a canyon-like situation. This canyon was kept, partially expanded and is designated to be considered for controlled surface water runoff from the stone quarry area in future plannings.

<b>Description of implementation</b>
<p>Stone quarry lake in the valley “Kirchsteigbachtal”. Source: P. Voigt</p>	<b>Effect horizon:</b> long-term
	<b>Costs:</b> 80.000 €
	<b>Involved stakeholders:</b> building department, lower water authority
	<b>Initiator / responsible:</b> City of Meissen
<b>Lessons-learned</b>	
<b>Main success factor:</b> Restoring of old, existing drainage systems brings many benefits: its effect becomes visible when it comes to a flood event. In contrast to a totally new investment, restoring of the existing drainage system might be less costly and is hence regarded as a reasonable decision by inhabitants. Little effort, high effect.	<b>Main challenge:</b> Finding a common solution with neighbouring property owners of the mill ditch for renaturation.  Consideration of nature conservancy concerns.  Ensuring long-term financing for continuous incidental maintenance costs.
