FACTSHEET RISK REDUCTION MEASURES	
Flood protection measures Ledenice - furrow and bypass channel	
Where was it implemented?

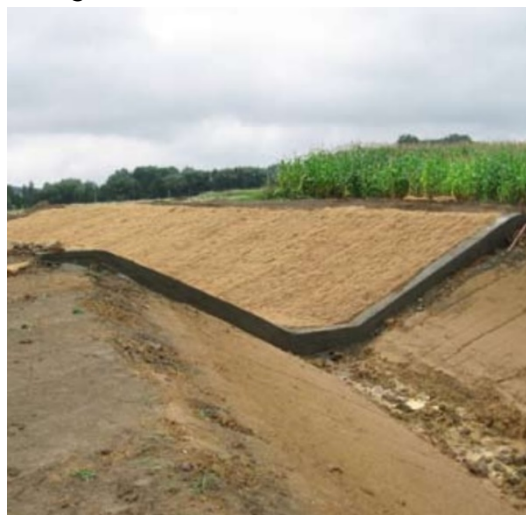
During realization:

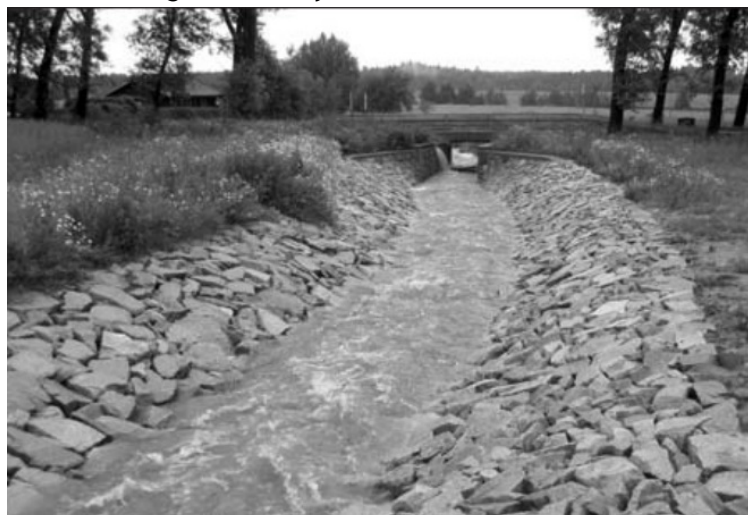
Channel filling durin heavy rain event in 2009:

Synergies / beneficial aspects: Protection of a large part of the municipality (including residential buildings) against recurrent flooding caused by heavy rain events. Complementation of the comprehensive flood protection of Ledenice. The bypass channel has already proven its effectiveness in 2009 and 2013.	Conflicts / Constraints: The realization of the second part of the bypass channel was delayed due to the postponement of the land consolidation.
Key message to others starting with a similar task	
The realization of the risk reduction measure was carried out according to a separate study. Construction of the bypass channel was started before the start of the land consolidation.	
Contact	
The Region of South Bohemia, The Section of Territorial Planning www.kraj-jihocesky.cz Contact list: https://www.kraj-jihocesky.cz/ku_tseznam/os?id_os=94

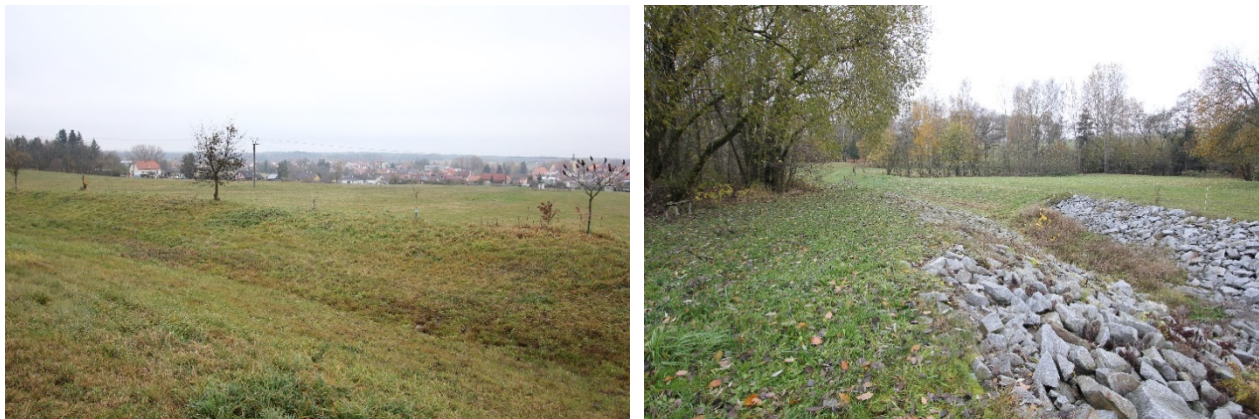
After realization:
