## FACTSHEET RISK REDUCTION MEASURES

### Flood protection measures Ledenice - other measures

Ledenice (South Bohemia Region, Czech Republic)

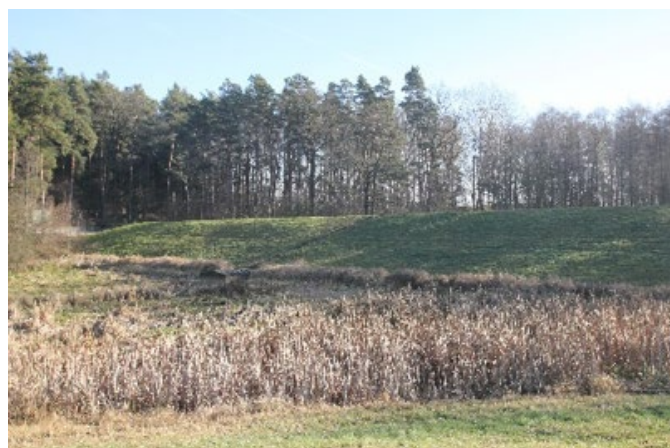
Dry retention reservoir

The following general measures have been proposed in addition to the bypass channel to reduce the flood risk: increasing the natural retention capacity of the landscape, the use of the valley morphology for the realization of a retention reservoir, increase in flow capacity of watercourses, replacement of non-capacity functional objects of water management works. The restoration of the Kačerovec dam is an essential part of these measures (individual examples of other measures are given in the first paragraph). The original flood dam was ruptured in 1925 and caused a flood in the entire catchment area of the Spolský stream, including damage to the dam of the Svět pond in Třeboň. The Kačerovec dam was realized as a retention reservoir with low water level - in periods without precipitation it can be dried out. The construction costs amounted to 12,936,000 CZK, with the municipality receiving a subsidy of the Ministry of the Environment (revitalization of river systems) in the amount of 10 million. Volume of constant water level - max. 9,730 m<sup>3</sup>, maximum retention volume 192,727 m<sup>3</sup>.

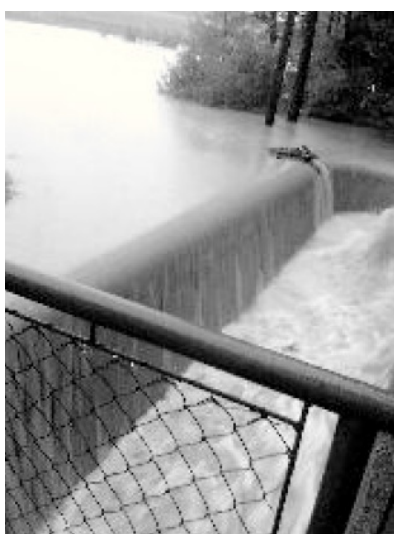
Retention reservoir Kačerovec during flood in 2013  
Source: Ledenický zpravodaj - municipality newsletter)

| Description of implementation | |
|--|---|
| <b>Synergies / beneficial aspects:</b><br>Protection of a large part of the municipality (including residential buildings) against recurrent floods caused by heavy rain events; complementation of the comprehensive flood protection of Ledenice. The retention reservoir has already proven its effectiveness in 2000 and 2013. | <b>Conflicts / Constraints:</b><br>The construction was delayed by looking for the necessary funds (the total financing would amount to ¼ of the annual costs in the municipality's budget) |

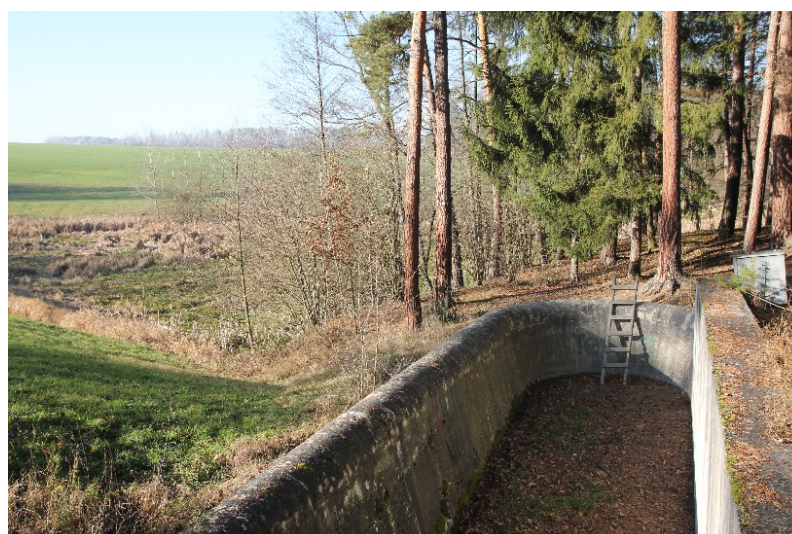
Spillway of the retention reservoir in 2019 (same place)  
Source: The Region of South Bohemia, The section of Territory Planning

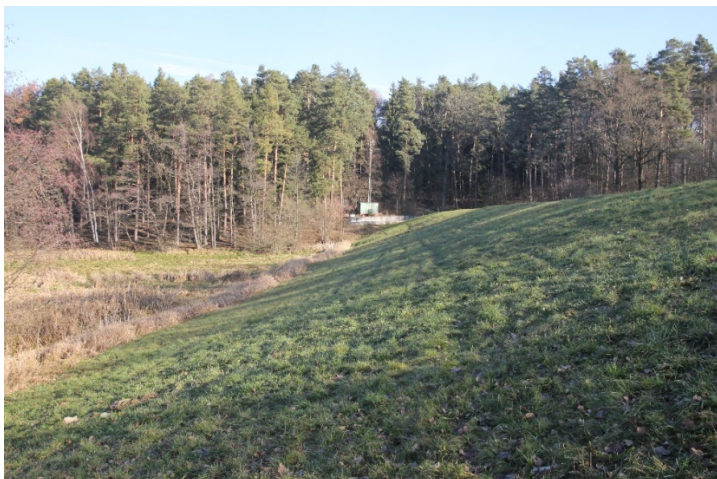
Retention reservoir dam

| Description of implementation | |
|--|---|
| <b>Main success factor:</b><br>Obtaining a subsidy from the Ministry of the Environment - the municipality had previously sought to build a retention reservoir, but without a subsidy implementation was not possible. | <b>Main challenge:</b><br>Technical design of retention reservoir dam to prevent repeated bursting of the retention reservoir and endangering the entire catchment area. |
