## FACTSHEET RISK COMMUNICATION MEASURES

Showing and explaining risk and risk reduction measures in the landscape - Establishment of a flood trail in Oderwitz

Oderwitz, Saxony, Germany

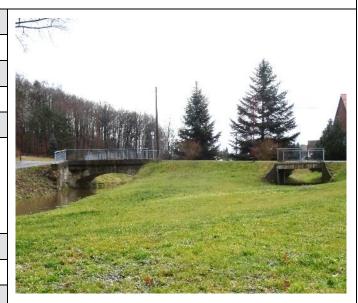
Culverts, such as the one on the right in the picture, improve the discharge conditions permanently only if their functionality is maintained. This can be very costly. Referring to such measures for flood protection, however, does not come to the mind of a municipal administration and is therefore not recognised by the residents. Cleverly used information signs can explain how systems work.

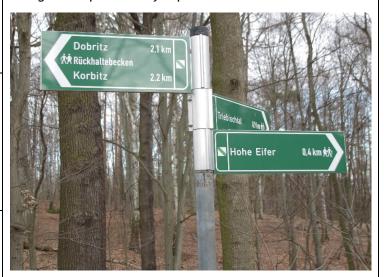
References in the landscape do not always have to be costly. Even the mention of a retention basin on a hiking trail signpost, such as in the Meissen Kirchsteigbach valley, explicates invisible flood protection measures and their functionality.
